# Manhole Inspection Summary

Manhole # S33K1\_020MH

Record Plat: **33K1** Node: **020** Status: **New Manhole (Not in GIS)** Insp Date: **4/29/09 12:00 AM**

**Location** Address: **2800 Potee St** Cross Street: **Waterview Ave**

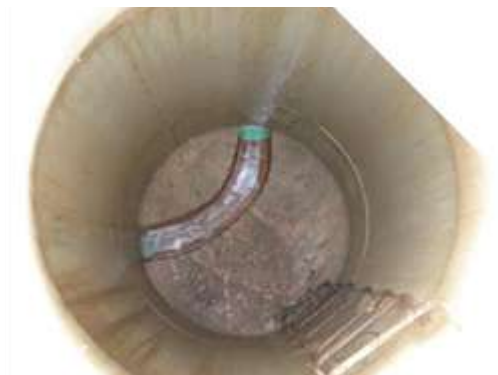
Top View

**Cover** Shape: **Circular** Diameter: **30** (in.) Length: (in.) Dist A/B Grade: **0** (in.)  
Type: **Sanitary** Condition: **Sound** Cover Material: **Cast Iron**  
Properties: ☐ Bolted ☐ Vented ☐ Water Tight ☐ Water Tight Insert

**Frame** Offset: **2** (in.) Condition: ☒ Sound ☐ Cracked ☐ Leaks

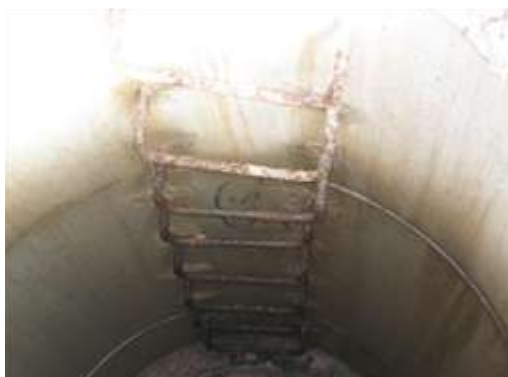
Steps

**Steps** Count: **8** Missing: **0** ☐ Corroded

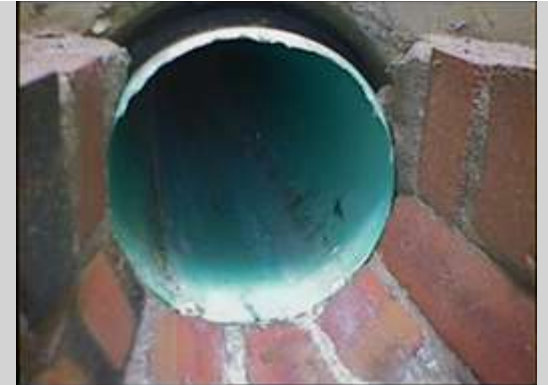
12 O'Clock Outflow

8 in. Circular Gravity Sewer  
Pipe Out @ 12 O'Clock

Pipe Height: **9.6** (in.) Rod and Bar (Angled)  
Pipe Material: **PVC** ☐ Pipe Lined  
Invert Depth: **10.65** (ft.) Flow Characteristics: **Slow**  
Deposits: ☒ None ☐ Mud ☐ Sludge ☐ Debris ☐ Grease  
Silt Depth: (in.) Deposits Extent:  
Infiltration: **None** Pipe Seal Cond: **Sound**

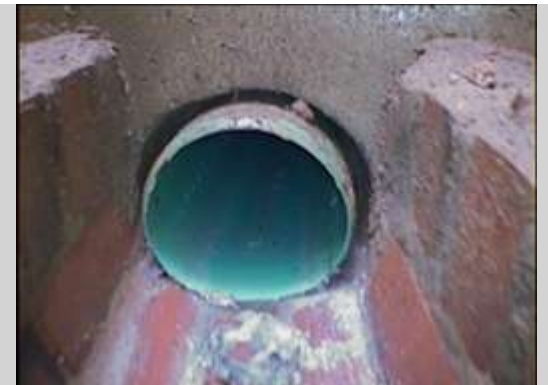
8 O'Clock Inflow

8 in. Circular Gravity Sewer  
Pipe In @ 8 O'Clock

Pipe Height: **8.4** (in.) Rod and Bar (Angled)  
Pipe Material: **PVC** ☐ Pipe Lined  
Invert Depth: **10.45** (ft.) Flow Characteristics: **Slow**  
Deposits: ☒ None ☐ Mud ☐ Sludge ☐ Debris ☐ Grease  
Silt Depth: (in.) Deposits Extent:  
Infiltration: **None** Pipe Seal Cond: **Sound**
